Digital

Introduction

This guide is in two parts, part 1 for HP Indigo presses and part 2 for dry toner digital presses. It covers some of the main issues when printing on creative papers, their causes and recommendations on how to achieve the best possible printing results.

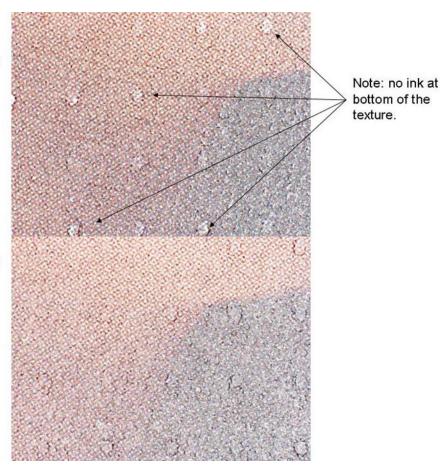
Poor bottoming of texture caused by insufficient blanket pressure

Good bottoming of texture caused by sufficient blanket

pressure

Textured papers have a surface structure with peaks and valleys. If the HP Indigo press is set up so that the blanket only has adequate pressure to transfer the ink to the peaks of the texture then poor transfer may result in the valleys of the texture. The HP Indigo system uses a compressible blanket that can produce good results on textured creative papers provided that the pressure is set correctly. For smooth papers the measured calliper of the paper can be used in the paper settings to achieve a good result but this may not give adequate results when printing on textured papers.

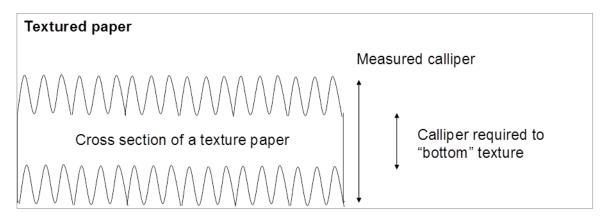
For most HP Indigo presses the pressure of the blanket is determined by the calliper setting in the selected substrate in the substrate list. For a textured paper the measured calliper will not give enough pressure to allow the HP Indigo blanket to conform to the bottom of the texture.

For textured papers, therefore, a lower than measured calliper setting should be used in the substrate settings. The actual calliper setting required to give good results for HP Indigo printing will vary according to the texture but a good place to start is to use the number grams in the weight of the paper in grams per metre squared as the calliper setting in micrometres. For example if the paper weight is indicated as 250g then the calliper setting should be set at 250 micrometres. Depending on the results the follow actions should be taken –

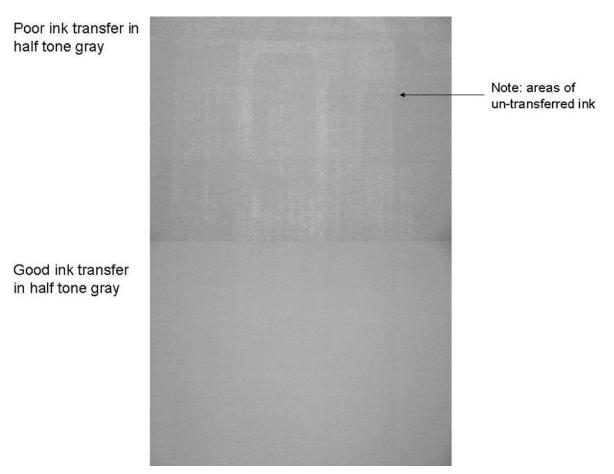
Poor ink transfer

• Too low blanket pressure - Many Creative papers benefit from high bulk and stiffness with a "soft" high quality wove finish. Although these papers may not look textured as such they have similar issues in terms pressure setting to textured papers. As discussed in the section on "non bottoming of texture" if the blanket pressure is set too low then not all the ink will transfer from the blanket to the paper leading to a build-up of ink on the blanket and to progressively poor image quality.

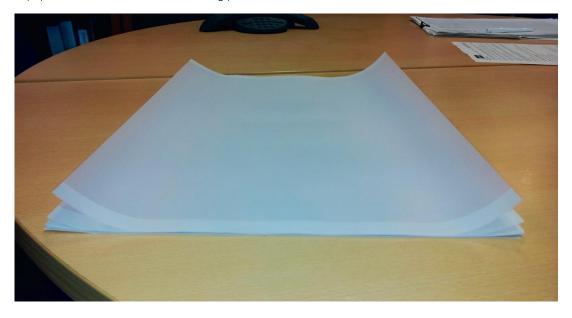
High paper curl caused by poor storage of paper or by poor control of press room conditions - Paper will increase or decrease in
moisture content if placed in an environment with higher or lower relative humidity. If the rate and degree of change in paper
moisture content is large then the paper is likely to curl in one or both planes and may, in extreme cases, develop a wavy edge.
All papers will have a tendency to curl when the moisture content is changed but this problem is particularly severe in the case of
translucent papers as can be seen on the following picture.

Translucent papers are extremely sensitive to changes in moisture. If press room humidity is not controlled and the ambient RH is either high or low then problems may be encountered with translucent paper runnability. If after conditioning the paper in its packaging for 24 hours the paper curls as illustrated in the picture above, check the ambient RH and if this is above 65% or below 45% abandon the print run until conditions are between these limits and the paper is flat.

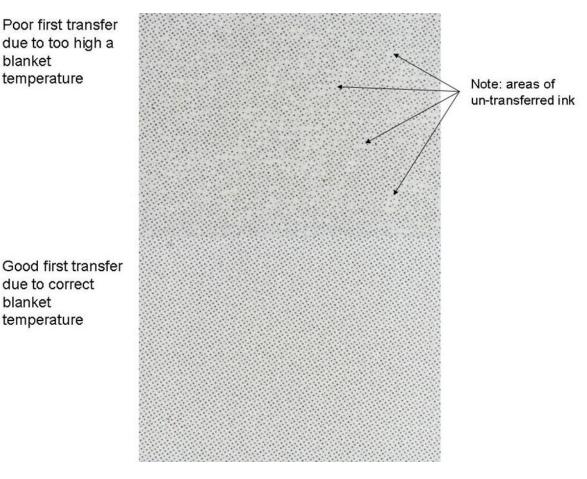
due to correct

blanket temperature

This is usually caused by poor transfer of small dots of ink from the photo imaging plate to the blanket. It is often more prevalent when the blanket is new. This issue tends not to be directly influenced by the paper but can be affected by the blanket temperature which associated with the paper settings.

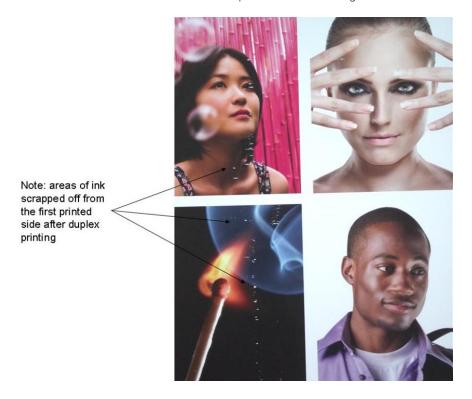
Ink scraping/marking can occur in heavy ink coverage areas on the first printed side of duplex prints particularly for thick boards. This affect can look like an ink transfer issue but there will be no build-up of ink on the HP Indigo blanket.

A part of the HP Indigo press duplexing system can lightly scrape the first printed side of the paper. The ink film has a relatively high oil content when just printed and the ink is soft and easily scraped off or marked at this stage of the process.

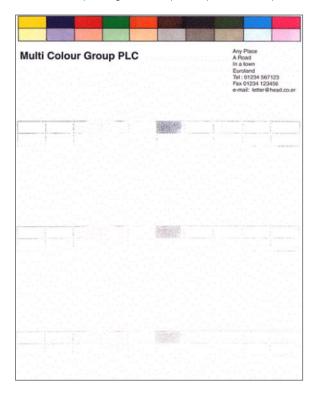
HP Indigo ink causes an affect like ink set off after printing in desktop laser printers (see picture below):

HP Indigo ink has a melting point around the temperature produced by the fusing systems my many desktop laser printing systems. Melted HP Indigo ink sticks to the laser printer fuser roll and then transfers further down the printed page.

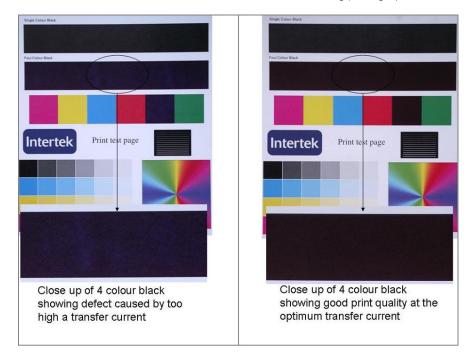
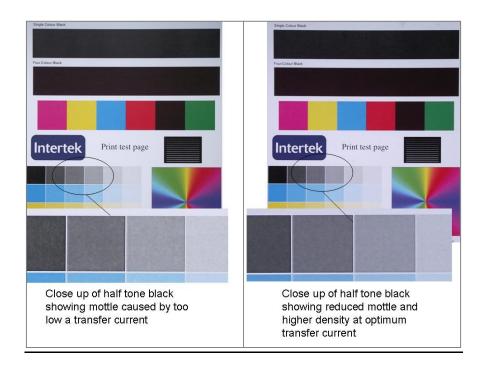
Print mottle can affect both half tones and solid colours as can be seen in the following photographs:

- The paper electrical resistivity
- The paper moisture content (moisture has the biggest effect on electrical resistivity)
- The paper thickness, uniformity of density and surface roughness

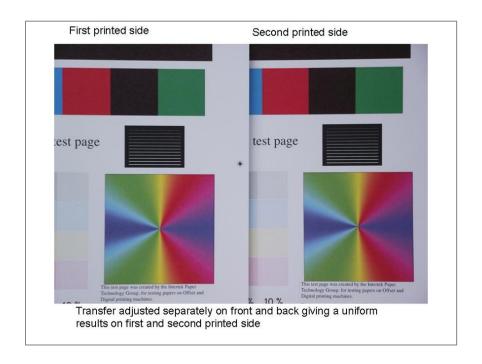
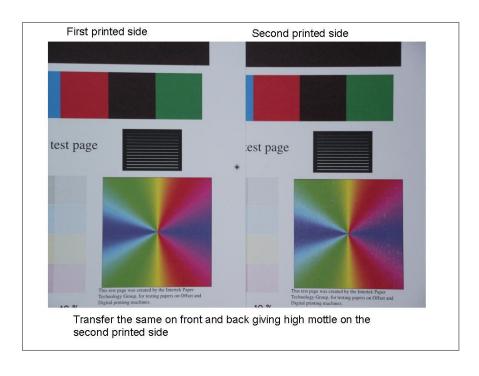
Poor print quality on one side of the substrate in duplex printing

Paper moisture content has a large effect on the transfer current required to give optimal print quality. When printing the first side of the sheet in duplexing printing the hot fusing process dries out the paper such that when the second side is printed the paper moisture content and, therefore, the optimal transfer current setting will be different. This affect is magnified as the weight of the paper increases because higher fusing temperatures are required for higher weight papers causing a bigger differential in moisture content between the first and second printed sides of the paper.

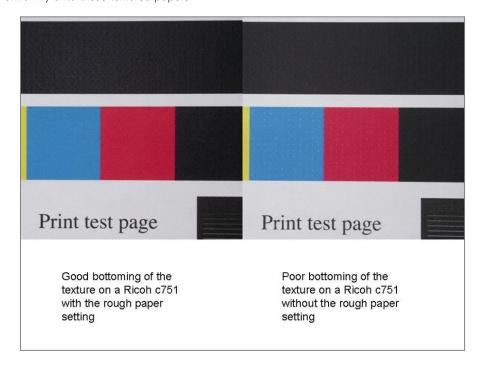
Some creative papers have interesting textures and finishes prized by designers. Unfortunately some dry toner presses cannot transfer the toner uniformly onto these textured papers.

As discussed on in the section about print mottle, dry toner presses use transfer currents to pull the toner onto the paper. If the texture of the paper is pronounced the paper cannot be charged uniformly across the texture and the toner will not be able to transfer properly into the bottom of the texture.

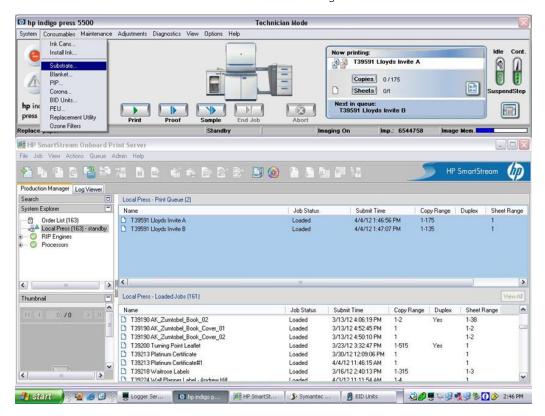
• Click on the consumables tab and select the Substrate setting:

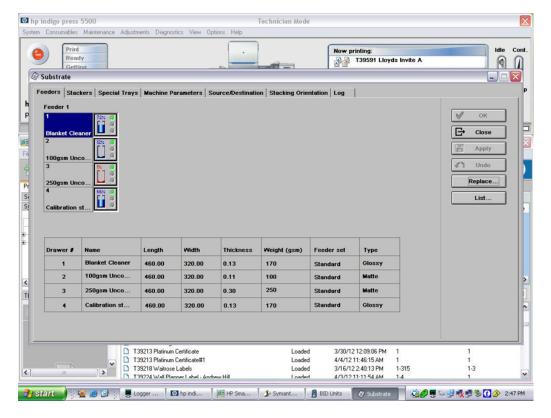
• In the Substrate window, select "List"

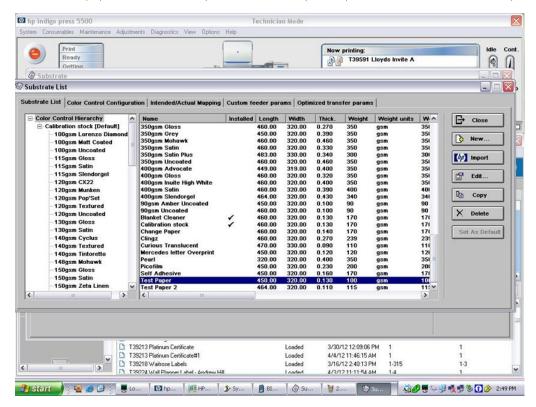
· Choose the paper from the list that you would like to adjust the pressure for, in this case "Test Paper"

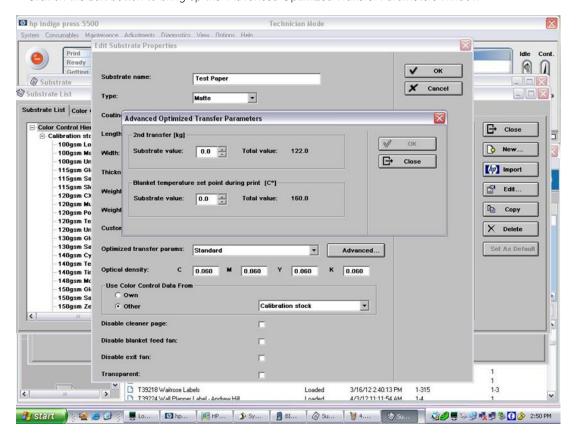
• Click on the Edit button to bring up the "Advanced Optimized Transfer Parameters window

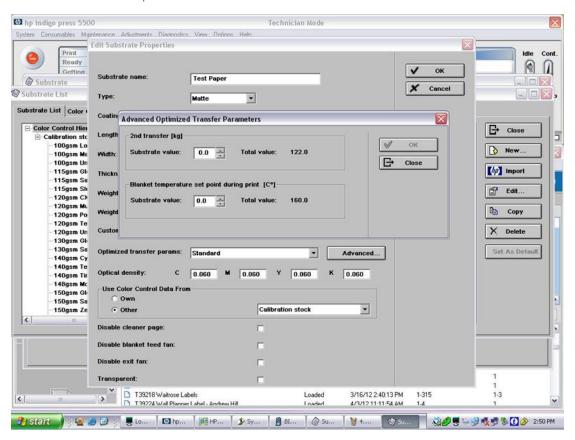
• To increase the blanket pressure increase the "Substrate value"

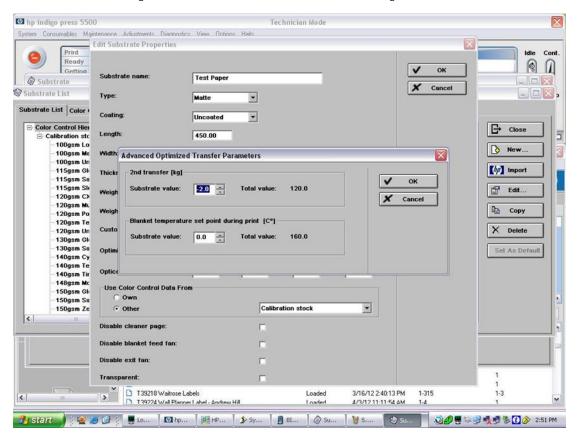
• Once the value is changed then click OK and then close the various dialogue boxes

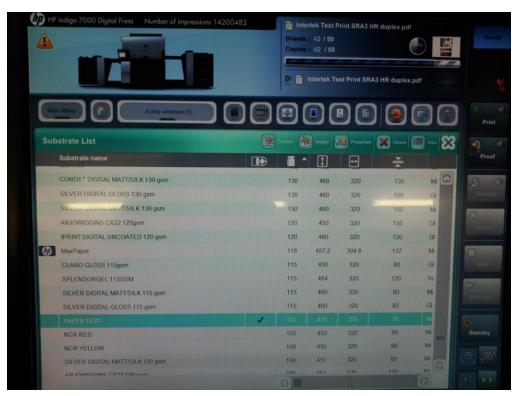
• Choose the substrate from the list that you would like to adjust the pressure for, in this case "Paper test"

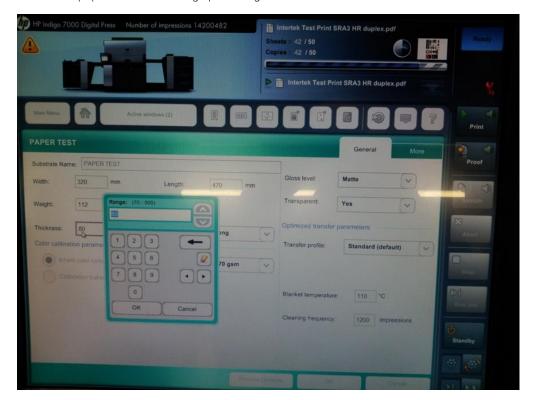
• Click on the paper thickness to bring up the range box

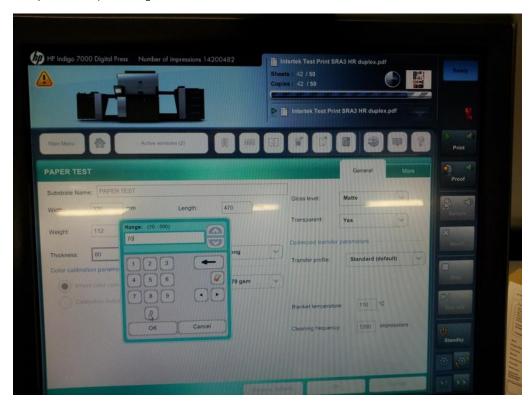
• Adjust the calliper setting to the new level and click OK

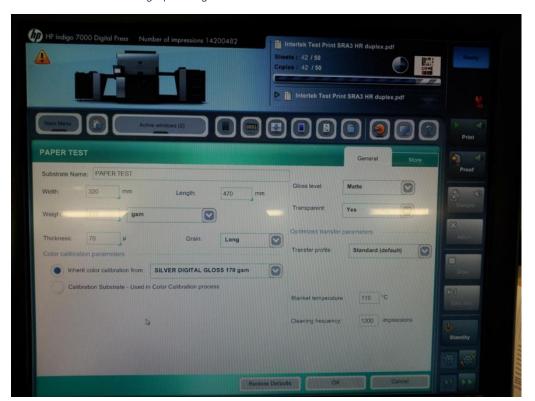
$\bullet\,$ Now save the new setting by clicking the OK button at the bottom of the screen
